**Flood Control Project Maintenance
Levee Inspections**

Maintenance Issue Types Only, Levee Inspection Report By Mile - Spring 2016

Reclamation District No. 0010 Honcut

Waterway	Bank	Unit Miles	Inspection Start/End	Inspector
Unit No. 01 Simmerly Slough	Right	7.65	04/20/2016 04/20/2016	Sterling York

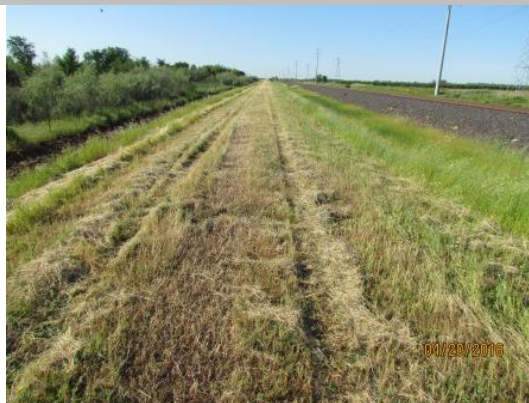
Photo 1 of 1 : SP_2016_RD0010_163_30_20160421_00061.jpg

LM Start	0.02	Rating **	M	Issue No.	30
LM End	7.64	Issue Type +	Ma	Location *	CR
Category	Earthen Levee			GPS Latitude/Longitude	
				Start	End
Item	Vegetation			39.163680 °	39.256051 °
				-121.609546 °	-121.574931 °
DWR ID	DWR_RD0010_01_s_2016_30				
Comment Code					
V1 : Control annual grass and weeds on the levee slopes and easements.					
Inspector Comment

View of vegetation on crown preventing an all season access road.

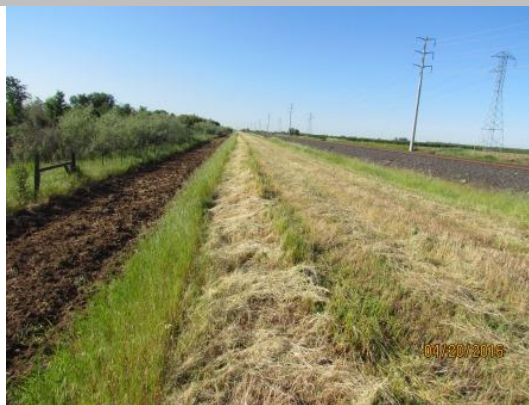
Photo 1 of 1 : SP_2016_RD0010_163_31_20160421_00062.jpg

LM Start	0.02	Rating **	M	Issue No.	31
LM End	7.64	Issue Type +	Ma	Location *	WS
Category	Earthen Levee			GPS Latitude/Longitude	
				Start	End
Item	Vegetation			39.163680 °	39.256052 °
				-121.609546 °	-121.574931 °
DWR ID	DWR_RD0010_01_s_2016_31				
Comment Code					
V1 : Control annual grass and weeds on the levee slopes and easements.					
Inspector Comment

View of typical vegetation on the waterside looking downstream.

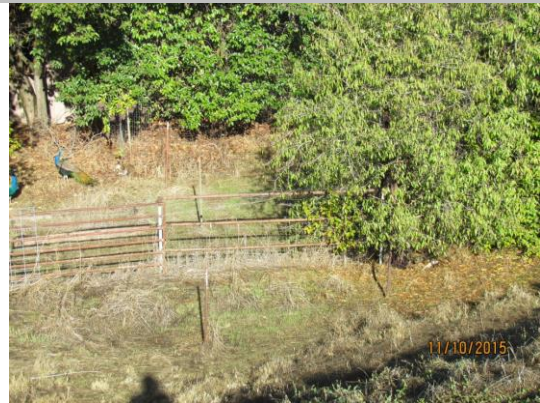
Photo 1 of 1 : SP_2016_RD0010_163_2_20160307_00001.jpg

LM Start	1.36	Rating **	M	Issue No.	2
LM End	1.36	Issue Type +	Ma	Location *	LS
Category	Earthen Levee			GPS Latitude/Longitude	
				Start	End
Item	Trim / Thin Trees			39.168769 °	39.168769 °
				-121.590409 °	-121.590409 °
DWR ID	DWR_RD0010_01_s _2016_2				
Comment Code					
T1 : Trim trees to at least five feet above ground level.					
Inspector Comment

View of the fence at the toe of the levee on the landward side of the levee. Fall 2015.

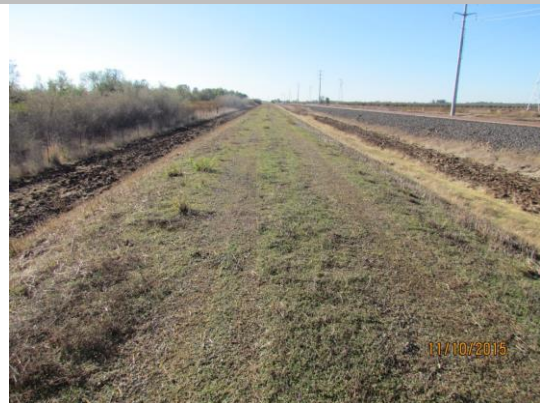
Photo 1 of 1 : SP_2016_RD0010_163_28_20160307_00006.jpg

LM Start	3.57	Rating **	A/W	Issue No.	28
LM End	7.64	Issue Type +	Ma	Location *	CR
Category	Earthen Levee			GPS Latitude/Longitude	
				Start	End
Item	Crown Surface / Depressions / Rutting			39.197526 °	39.255993 °
				-121.582294 °	-121.574930 °
DWR ID	DWR_RD0010_01_f_2015_28				
Comment Code					
C1 : Add appropriate material and re-grade the levee to bring the crown above the design elevation.					
Inspector Comment					
Crown needs to be re-graded. LMA is in the proces of regrading the levee in correspondence with DWR.

View of the crown of the levee looking downstream. Fall 2015.

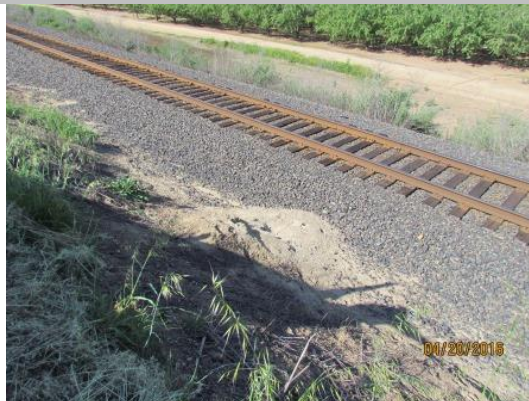
Photo 1 of 1 : SP_2016_RD0010_163_51_20160421_00072.jpg

LM Start	3.75	Rating **	U	Issue No.	51
LM End	3.75	Issue Type +	Ma	Location *	LS
Category	Earthen Levee			GPS Latitude/Longitude	
				Start	End
Item	Animal Control			39.200003 °	39.200003 °
				-121.582002 °	-121.582002 °
DWR ID	DWR_RD0010_01_s _ 2016_51				
Comment Code					
A3 : No rodents visible, but rodent burrows visible; need to backfill and compact or grout burrows.					
Inspector Comment

View of large burrow on landside.

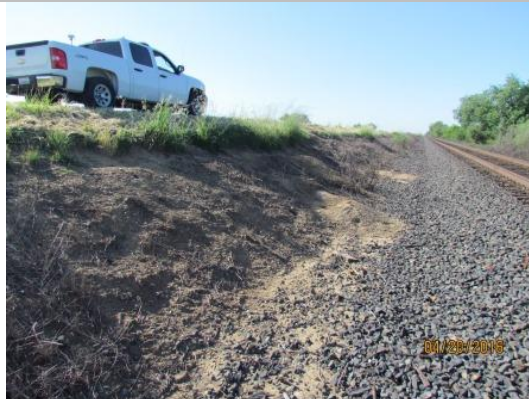
Photo 1 of 1 : SP_2016_RD0010_163_41_20160421_00071.jpg

LM Start	5.45	Rating **	M	Issue No.	41
LM End	5.45	Issue Type +	Ma	Location *	LS
Category	Earthen Levee			GPS Latitude/Longitude	
				Start	End
Item	Animal Control			39.224485 °	39.224485 °
				-121.578944 °	-121.578944 °
DWR ID	DWR_RD0010_01_s_2016_41				
Comment Code					
A1 : Exterminate rodents and backfill and compact or grout burrows.					
Inspector Comment

View of multiple active ground squirrel holes on landside slope looking downstream.

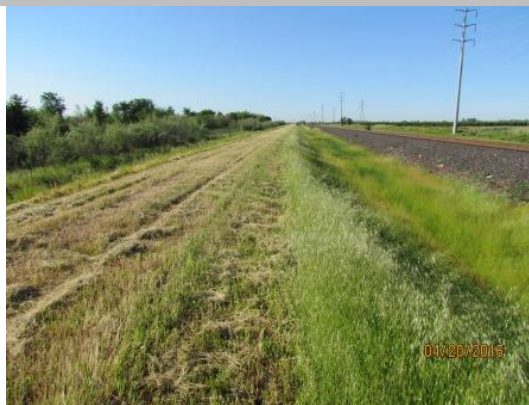
Photo 1 of 1 : SP_2016_RD0010_163_29_20160421_00060.jpg

LM Start	6.11	Rating **	M	Issue No.	29
LM End	7.64	Issue Type +	Ma	Location *	LS
Category	Earthen Levee			GPS Latitude/Longitude	
				Start	End
Item	Vegetation			39.233968 °	39.256050 °
				-121.577770 °	-121.574930 °
DWR ID	DWR_RD0010_01_s _ 2016_29				
Comment Code					
V1 : Control annual grass and weeds on the levee slopes and easements.					
Inspector Comment

View of typical vegetation on the land side looking downstream.

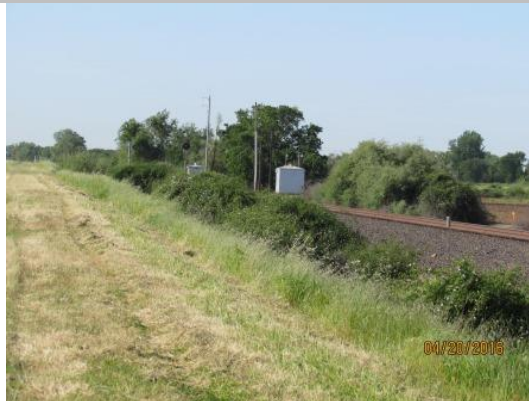
Photo 1 of 1 : SP_2016_RD0010_163_36_20160421_00070.jpg

LM Start	6.18	Rating **	M	Issue No.	36
LM End	6.34	Issue Type +	Ma	Location *	LS
Category	Earthen Levee			GPS Latitude/Longitude	
				Start	End
Item	Vegetation			39.235067 °	39.237286 °
				-121.577541 °	-121.577218 °
DWR ID	DWR_RD0010_01_s_2016_36				
Comment Code					
V2 : Remove the wild growth other than native grasses from the levee slopes.					
Inspector Comment					
Large cluster of wild Rosebushes on landside slope & toe.

View looking downstream landside of wild rosebushes that are blocking visibility at the toe.

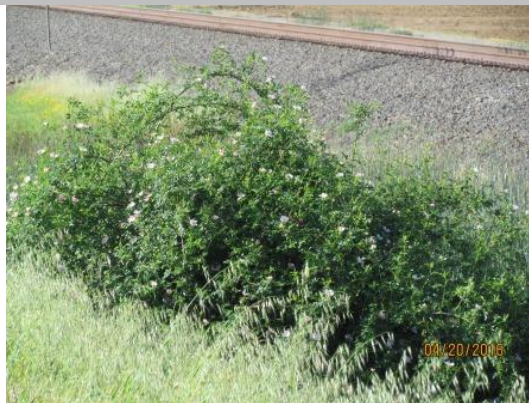
Photo 1 of 1 : SP_2016_RD0010_163_34_20160421_00065.jpg

LM Start	6.86	Rating **	M	Issue No.	34
LM End	6.86	Issue Type +	Ma	Location *	LS
Category	Earthen Levee			GPS Latitude/Longitude	
				Start	End
Item	Vegetation			39.244811 °	39.244811 °
				-121.576277 °	-121.576277 °
DWR ID	DWR_RD0010_01_s_2016_34				
Comment Code					
V2 : Remove the wild growth other than native grasses from the levee slopes.					
Inspector Comment

View of thick wild rose bush that obstructs visibility of the landside slope and toe.

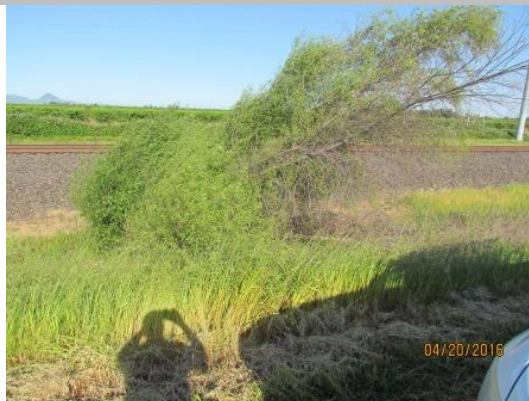
Photo 1 of 1 : SP_2016_RD0010_163_32_20160421_00064.jpg

LM Start	7.27	Rating **	M	Issue No.	32
LM End	7.27	Issue Type +	Ma	Location *	LS
Category	Earthen Levee			GPS Latitude/Longitude	
				Start	End
Item	Trim / Thin Trees			39.250651 °	39.250651 °
				-121.575579 °	-121.575579 °
DWR ID	DWR_RD0010_01_s_2016_32				
Comment Code					
T1 : Trim trees to at least five feet above ground level.					
Inspector Comment					
Small trees 4" in diameter at chest height should be removed before they get to big.

View of a tree that needs to be removed. Small trees 4" in diameter at chest height should be removed before they get to big. View of landside.

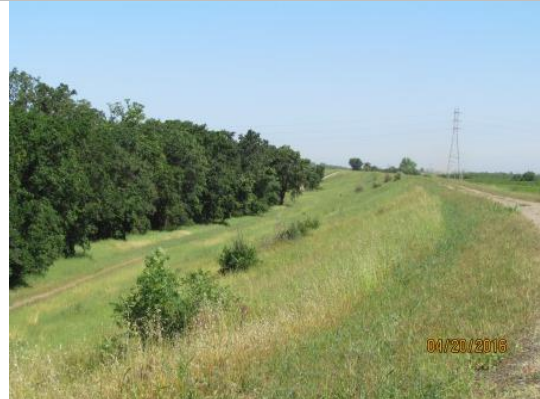
Photo 1 of 1 : SP_2016_RD0010_164_24_20160421_00064.jpg

LM Start	0.10	Rating **	M	Issue No.	24
LM End	11.34	Issue Type +	Ma	Location *	WS
Category	Earthen Levee			GPS Latitude/Longitude	
				Start	End
Item	Vegetation			39.165167 °	39.309707 °
				-121.610206 °	-121.616552 °
DWR ID	DWR_RD0010_02_s_2016_24				
Comment Code					
V1 : Control annual grass and weeds on the levee slopes and easements.					
Inspector Comment

View of typical vegetation on the waterside looking upstream.

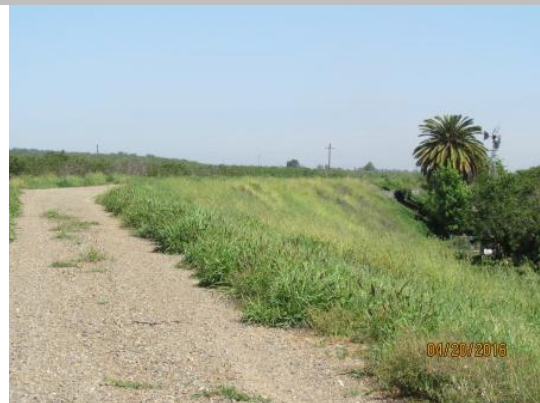
Photo 1 of 1 : SP_2016_RD0010_164_23_20160421_00065.jpg

LM Start	0.10	Rating **	M	Issue No.	23
LM End	11.34	Issue Type +	Ma	Location *	LS
Category	Earthen Levee			GPS Latitude/Longitude	
				Start	End
Item	Vegetation			39.165167 °	39.309707 °
				-121.610207 °	-121.616553 °
DWR ID	DWR_RD0010_02_s_2016_23				
Comment Code					
V1 : Control annual grass and weeds on the levee slopes and easements.					
Inspector Comment

View of typical vegetation on landside looking upstream.

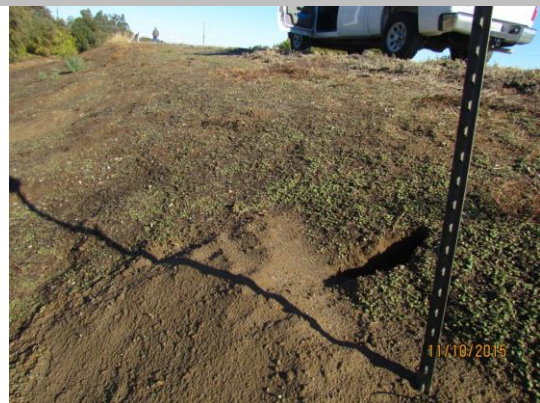
Photo 1 of 1 : SP_2016_RD0010_164_28_20160307_00003.jpg

LM Start	0.38	Rating **	M	Issue No.	28
LM End	0.38	Issue Type +	Ma	Location *	WS
Category	Earthen Levee			GPS Latitude/Longitude	
				Start	End
Item	Animal Control			39.169231 °	39.169231 °
				-121.610711 °	-121.610711 °
DWR ID	DWR_RD0010_02_f_2015_28				
Comment Code					
A3 : No rodents visible, but rodent burrows visible; need to backfill and compact or grout burrows.					
Inspector Comment

View of the rodent hole on the waterward side of the levee looking upstream. Fall 2015.

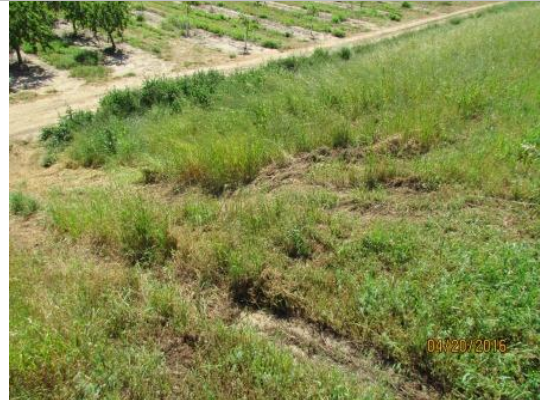
Photo 1 of 1 : SP_2016_RD0010_164_26_20160421_00066.jpg

LM Start	0.80	Rating **	M	Issue No.	26
LM End	0.80	Issue Type +	Ma	Location *	LS
Category	Earthen Levee			GPS Latitude/Longitude	
				Start	End
Item	Slope Stability			39.175195 °	39.175195 °
				-121.609854 °	-121.609854 °
DWR ID	DWR_RD0010_02_s _ 2016_26				
Comment Code					
S3 : Repair the levee slope damaged by vehicle traffic and prevent access where possible.					
Inspector Comment

Rutting on landside slope due to vehicle traffic.

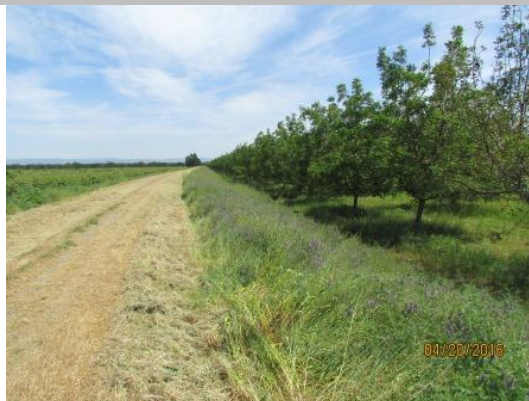
Photo 1 of 1 : SP_2016_RD0010_165_4_20160421_00010.jpg

LM Start	0.01	Rating **	M	Issue No.	4
LM End	2.80	Issue Type +	Ma	Location *	LS
Category	Earthen Levee			GPS Latitude/Longitude	
				Start	End
Item	Vegetation			39.310111 °	39.298530 °
				-121.616223 °	-121.569994 °
DWR ID	DWR_RD0010_03_s_2016_4				
Comment Code					
V1 : Control annual grass and weeds on the levee slopes and easements.					
Inspector Comment

View of typical vegetation on the landside looking upstream.

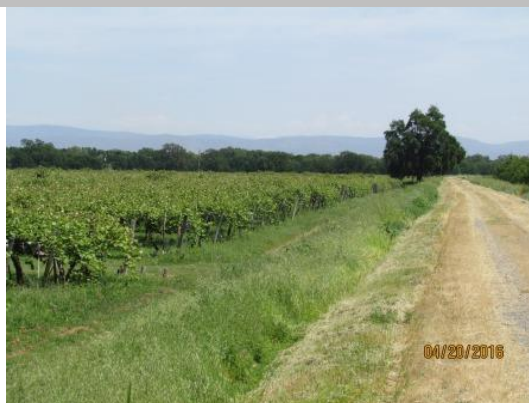
Photo 1 of 1 : SP_2016_RD0010_165_6_20160421_00011.jpg

LM Start	0.01	Rating **	M	Issue No.	6
LM End	2.80	Issue Type +	Ma	Location *	WS
Category	Earthen Levee			GPS Latitude/Longitude	
				Start	End
Item	Vegetation			39.310111 °	39.298530 °
				-121.616222 °	-121.569994 °
DWR ID	DWR_RD0010_03_s_2016_6				
Comment Code					
V1 : Control annual grass and weeds on the levee slopes and easements.					
Inspector Comment

Typical vegetation on the waterside looking upstream.

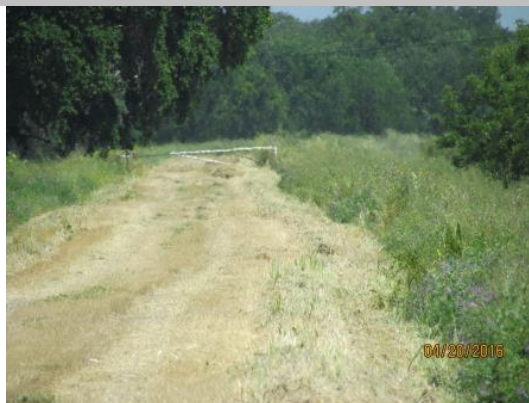
Photo 1 of 1 : SP_2016_RD0010_165_5_20160421_00012.jpg

LM Start	0.01	Rating **	M	Issue No.	5
LM End	2.80	Issue Type +	Ma	Location *	CR
Category	Earthen Levee			GPS Latitude/Longitude	
				Start	End
Item	Vegetation			39.310111 °	39.298530 °
				-121.616220 °	-121.569994 °
DWR ID	DWR_RD0010_03_s_2016_5				
Comment Code					
V1 : Control annual grass and weeds on the levee slopes and easements.					
Inspector Comment

View of vegetation that has overgrown the crown looking upstream.

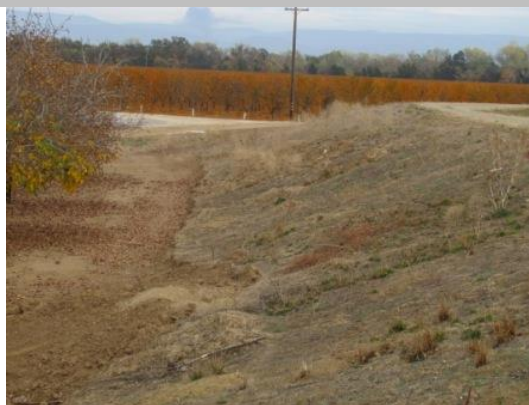
Photo 1 of 1 : SP_2016_RD0010_165_18_20160307_00001.jpg

LM Start	1.67	Rating **	M	Issue No.	18
LM End	1.67	Issue Type +	Ma	Location *	WS
Category	Earthen Levee			GPS Latitude/Longitude	
				Start	End
Item	Slope Stability			39.302904 °	39.302904 °
				-121.588578 °	-121.588578 °
DWR ID	DWR_RD0010_03_f_2013_18				
Comment Code					
S3 : Repair the levee slope damaged by vehicle traffic and prevent access where possible.					
Inspector Comment					
Toe cut at edge of waterward side of levee.

This photo was taken from the levee crown facing north looking down the waterward slope at agricultural tilling causing a cut at the levee toe. Fall 2013.
